# Bulk Fuel Itinerant AST Training Checklist

**Iliamna**

**Iliamna fuel facility**

**Jun 24, 2020**

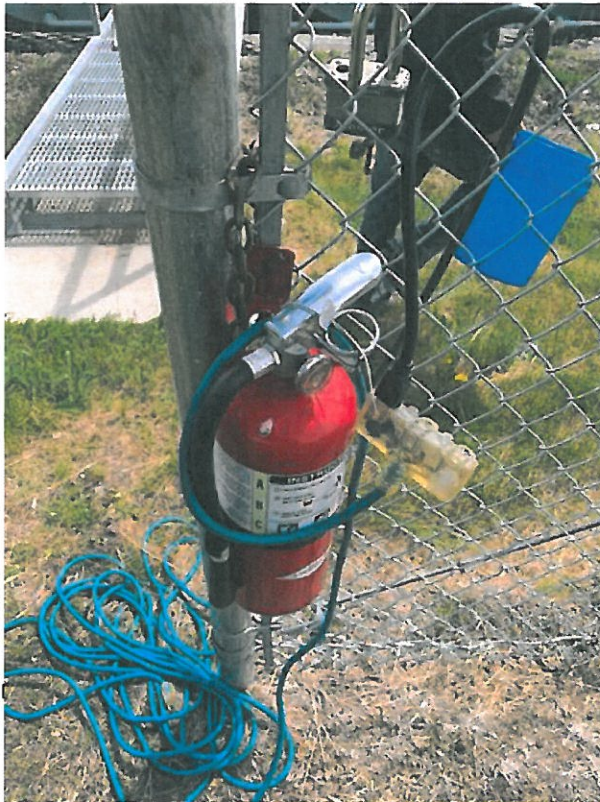
#### 2a - Fire Extinguishers

**Pass**

**Adequate number of fire extinguishers observed on site.**

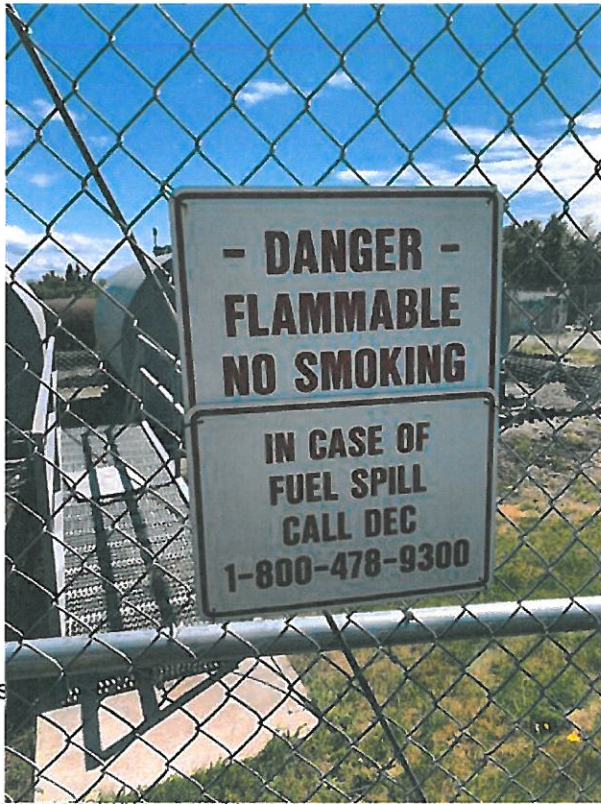
2b - No Smoking Signs

**Pass**

**Proper signage posted throughout facility.**

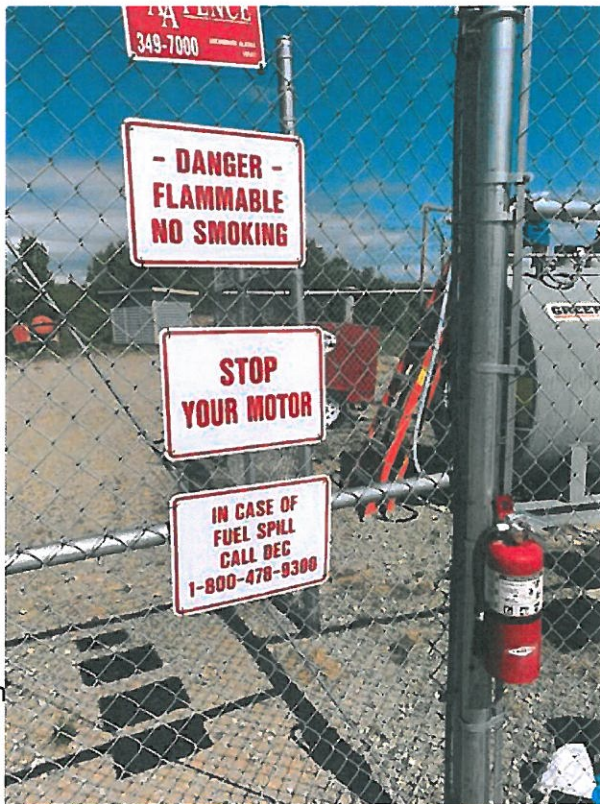
2c - Danger and Warning Signs

**Pass**

**Danger and warning signs were observed throughout facility.**

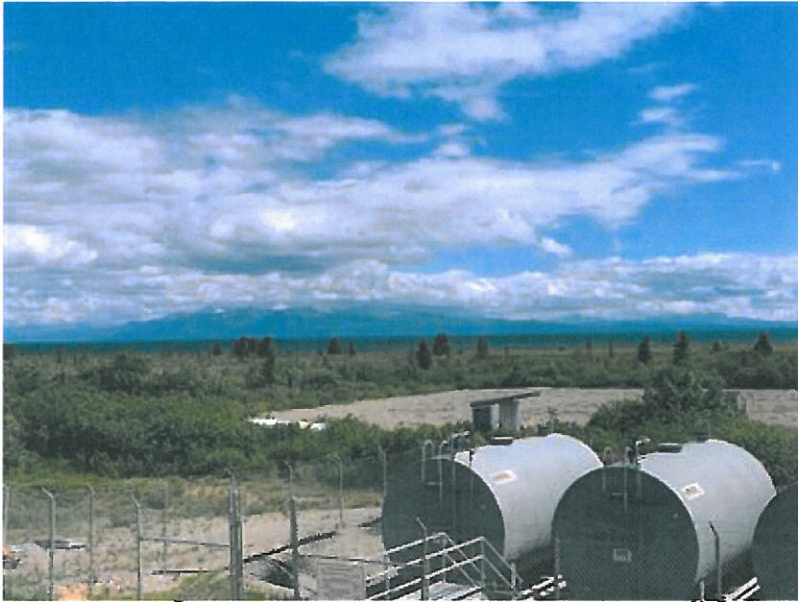
3a - Fencing

**Pass**

**Fencing was in good condition.**

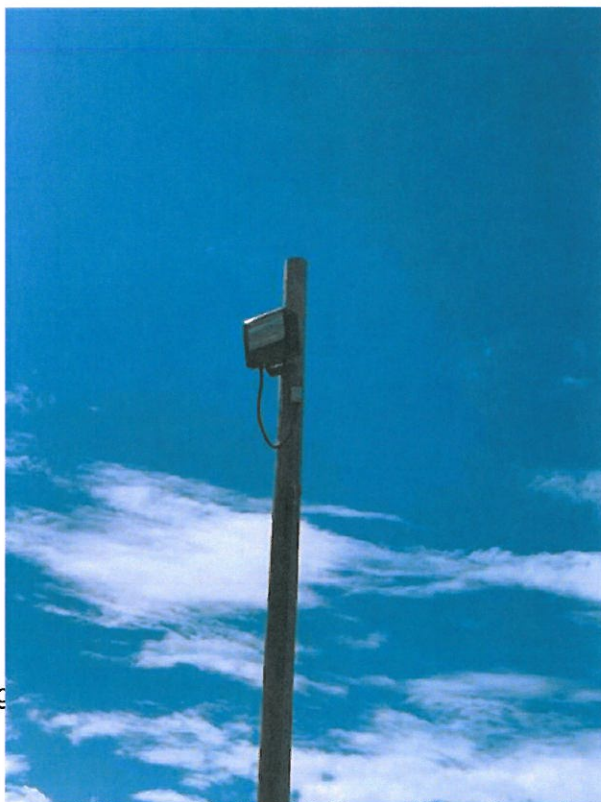
3b - Lightnig

**Pass**

**Single light source for fuel facility.**

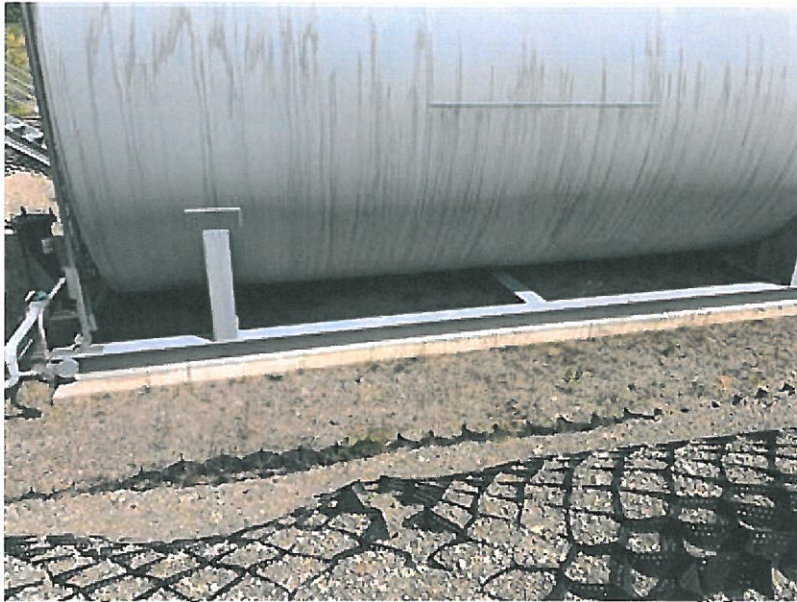
##### 4b - Signs of Corrosion

**Pass**

**Coating on tanks was still in good shape, no rust or corrosion observed.**

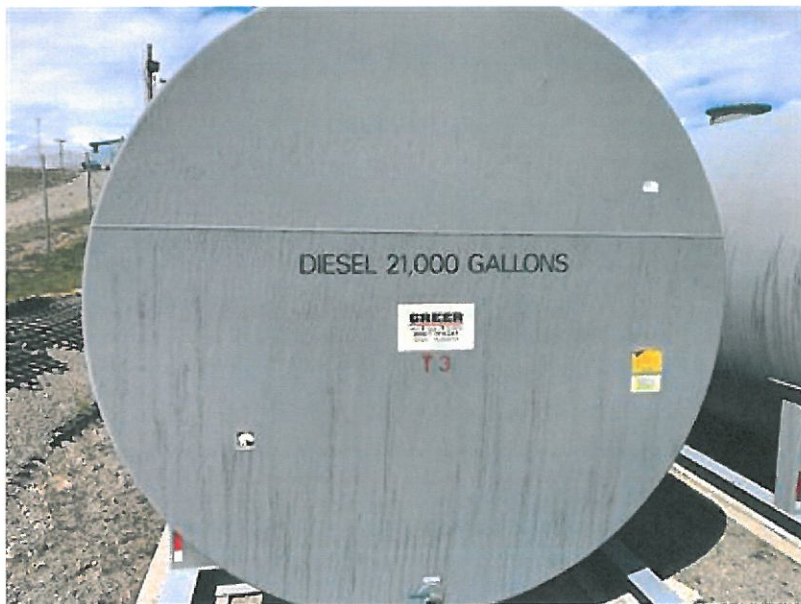
4e - Signage

**Pass**

**Proper labeling on each was observed with product and capacity.**

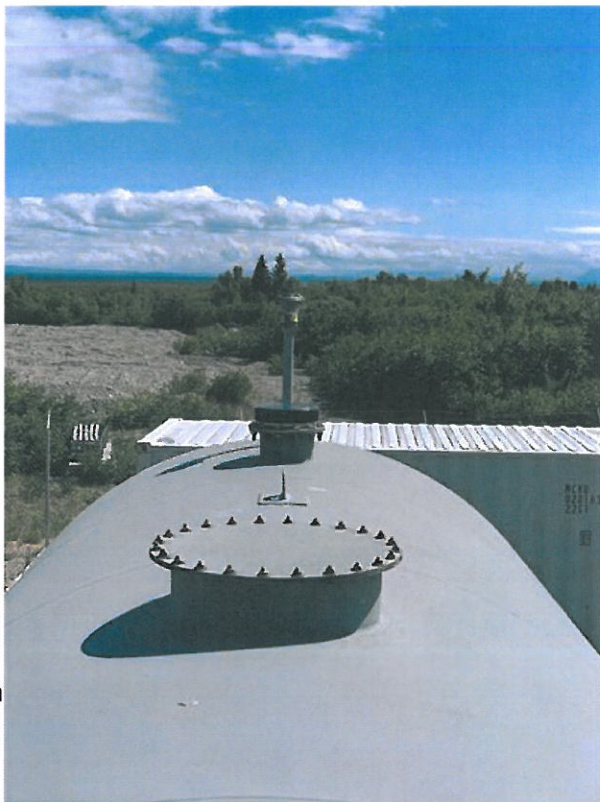
4g - Tank Vents

**Pass**

**Tanks vents clear with no signs on blockage or obstruction.**

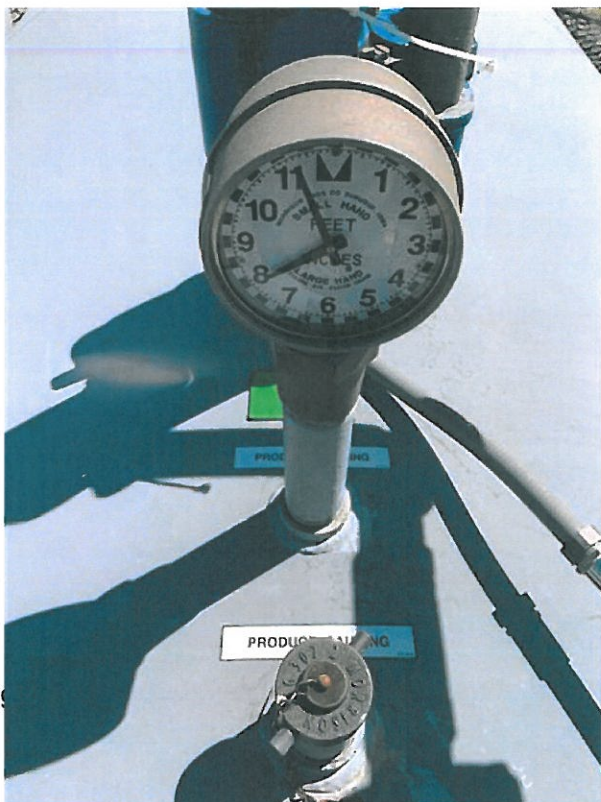
4h - Emergency Vents

**Pass**

**Emergency vent lids moved freely at each tank.**

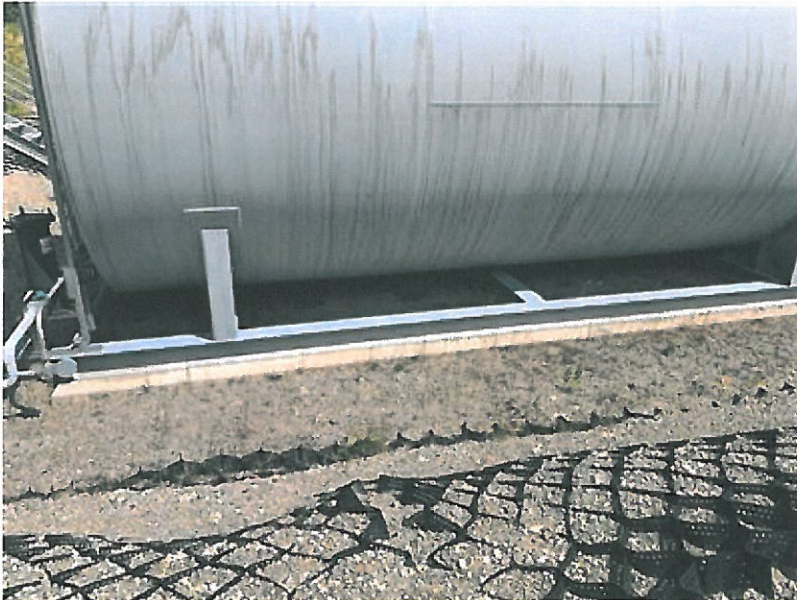
## 4I - Foundations

**Pass**

**Foundations were observed with no cracks and to be level.**

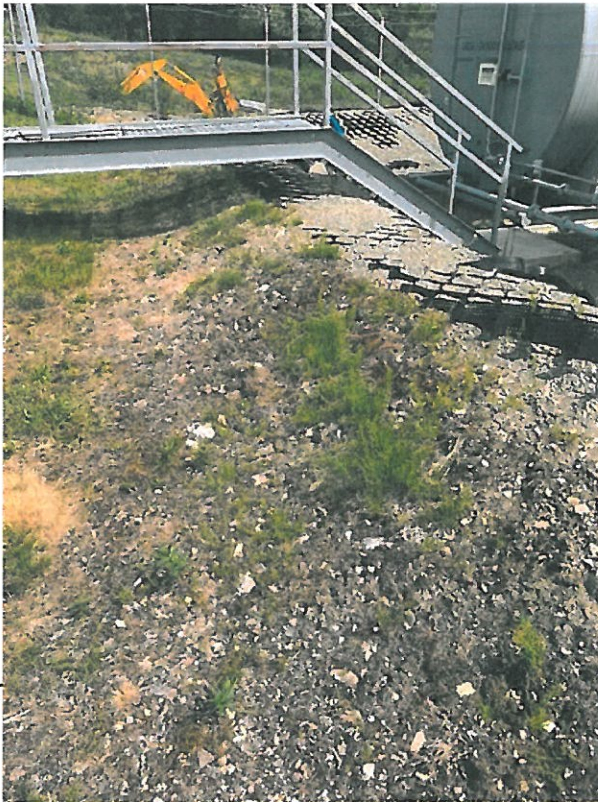
## 5f - Protection

**Pass**

**Piping was away from foot traffic as well as protected from ice and snow.**

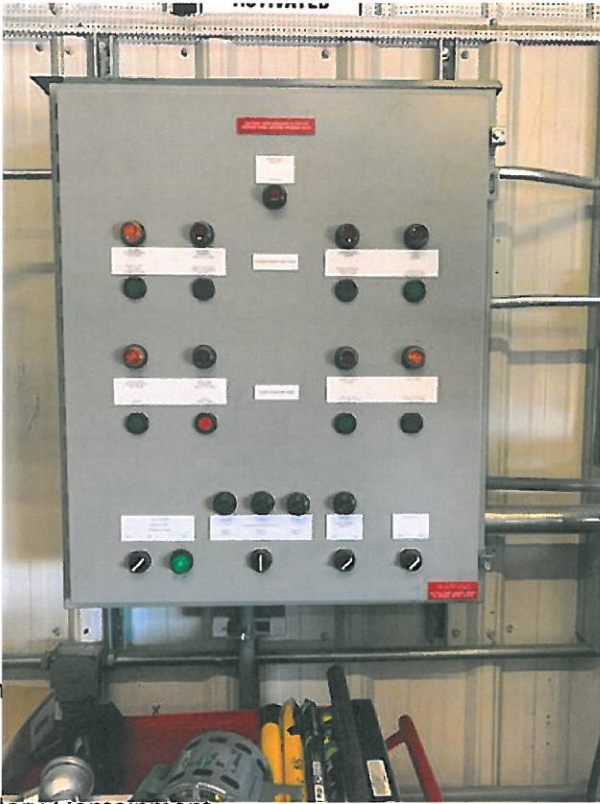
5i - Control Panel

**Pass**

**Control panel is located in power house. It was observed in good working condition.**

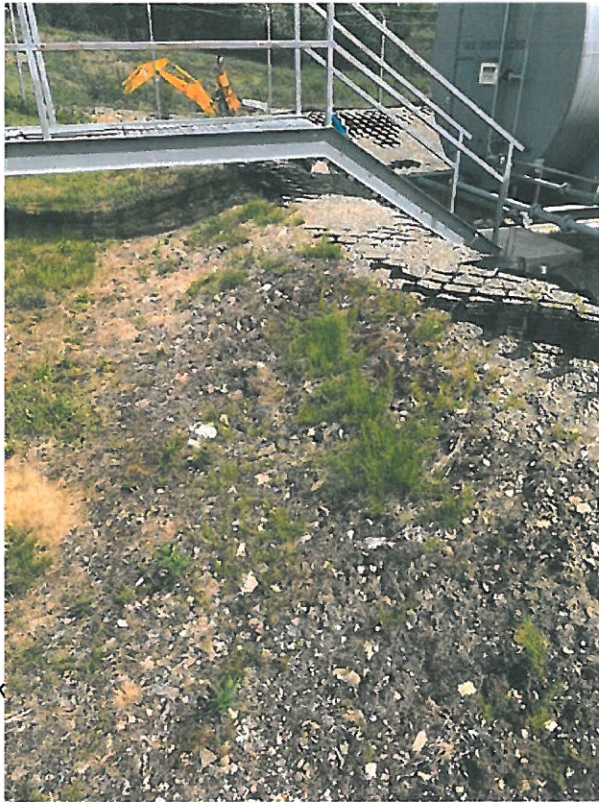
6a - Dike Integrity

**Pass**

**Dike was observed to be in good condition with no holes or damage to walls.**

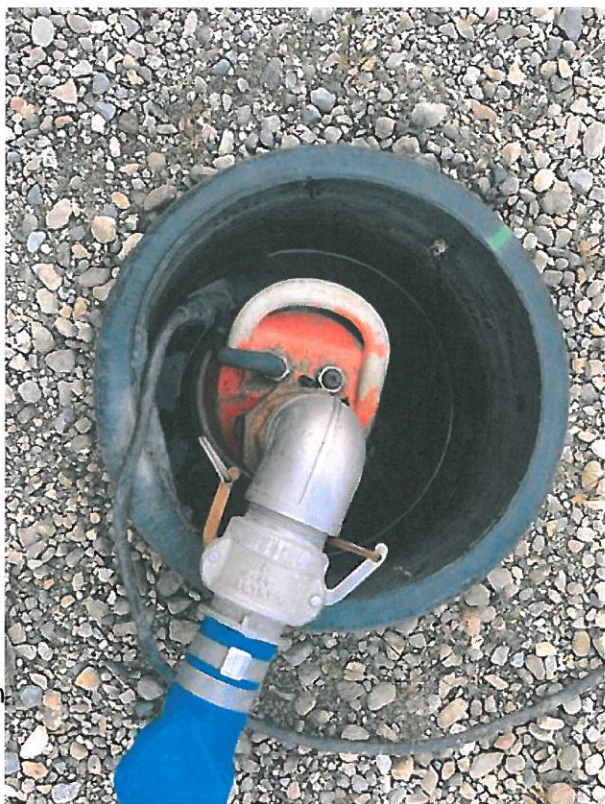
6b - Liner Integrity

**Pass**

**Liner was synthetic liner, liner was holding some rain water which shows integrity of liner.**

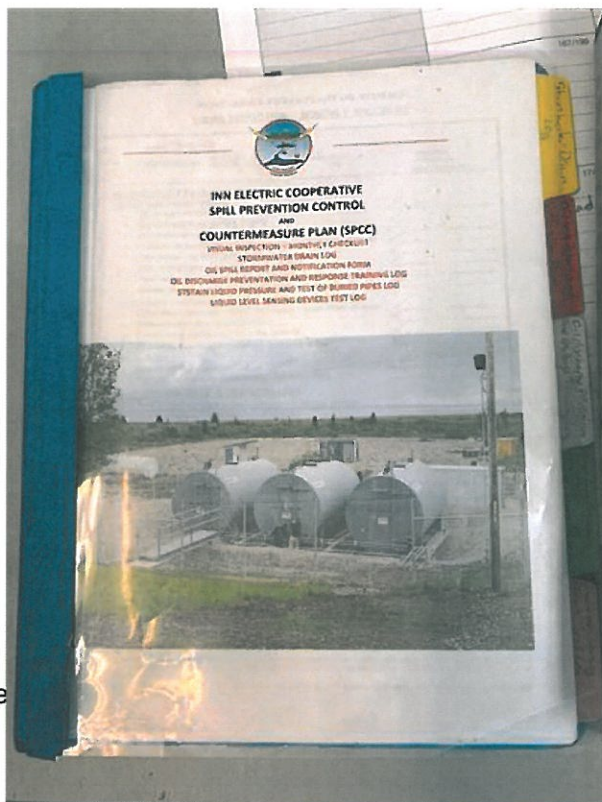
7a - Response Plan

**Pass**

**Facility had up to date response plan.**

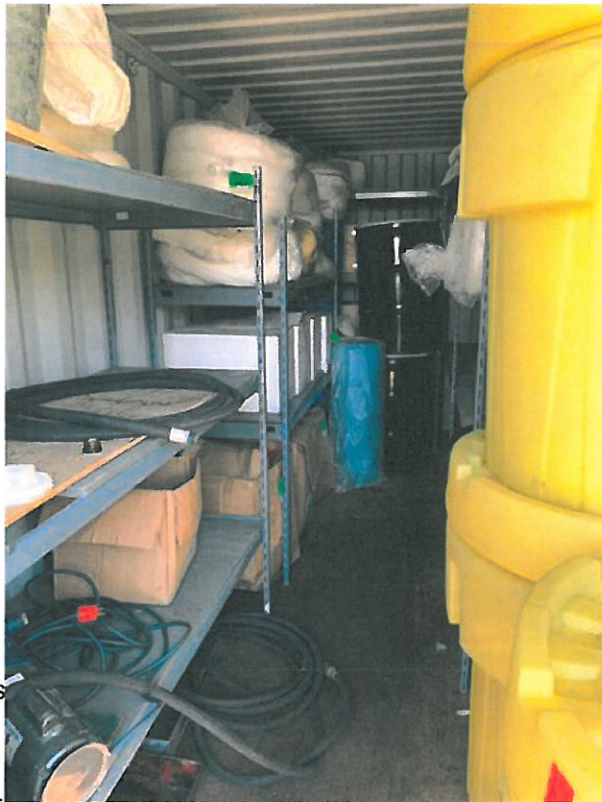
7b - Response Equipment

**Pass**

**Conex in fenced in tank area had adequate response equipment.**

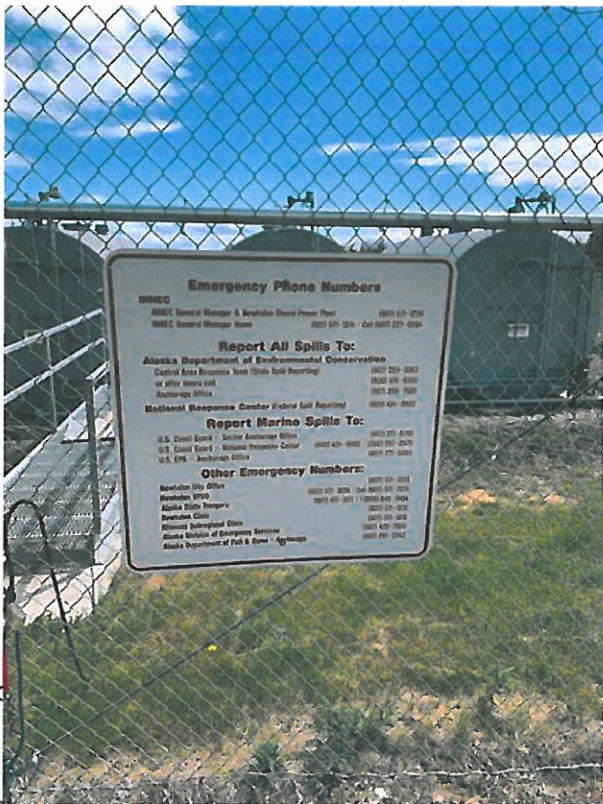
8a - ADEC Placards

**Pass**

**ADEC placards were observed throughout facility.**

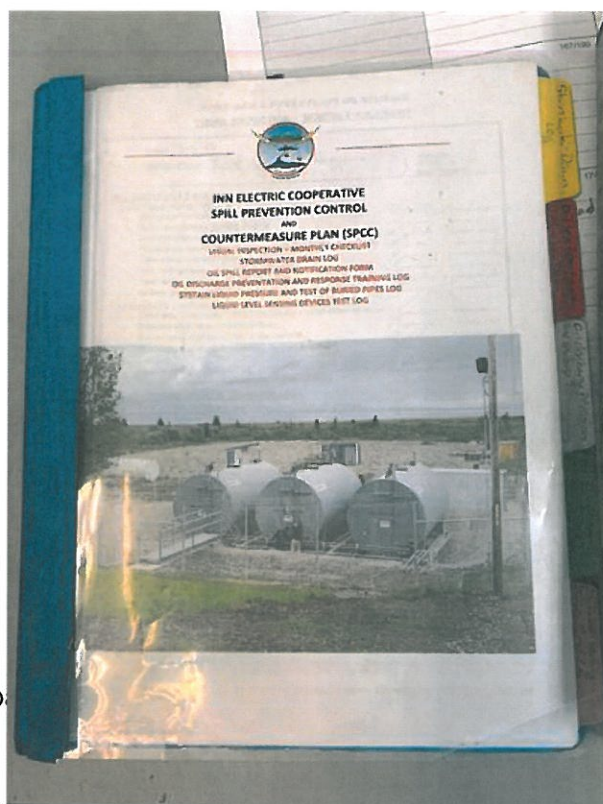
8b - EPA SPCC and FRP Plans

Pass

EPA SPCC and FRP Plans observed to be up to date.
